REPORT OF TELEVISION BOREHOLE SURVEY  
OF WELL NUMBER 3  
Iroquois Service Area  
New York State Thruway

March 20, 1970

Project: Well Number 3  
Iroquois-Indian Castle Service Area  
Project No. E101254-071

Subject: Television  
Borehole Survey

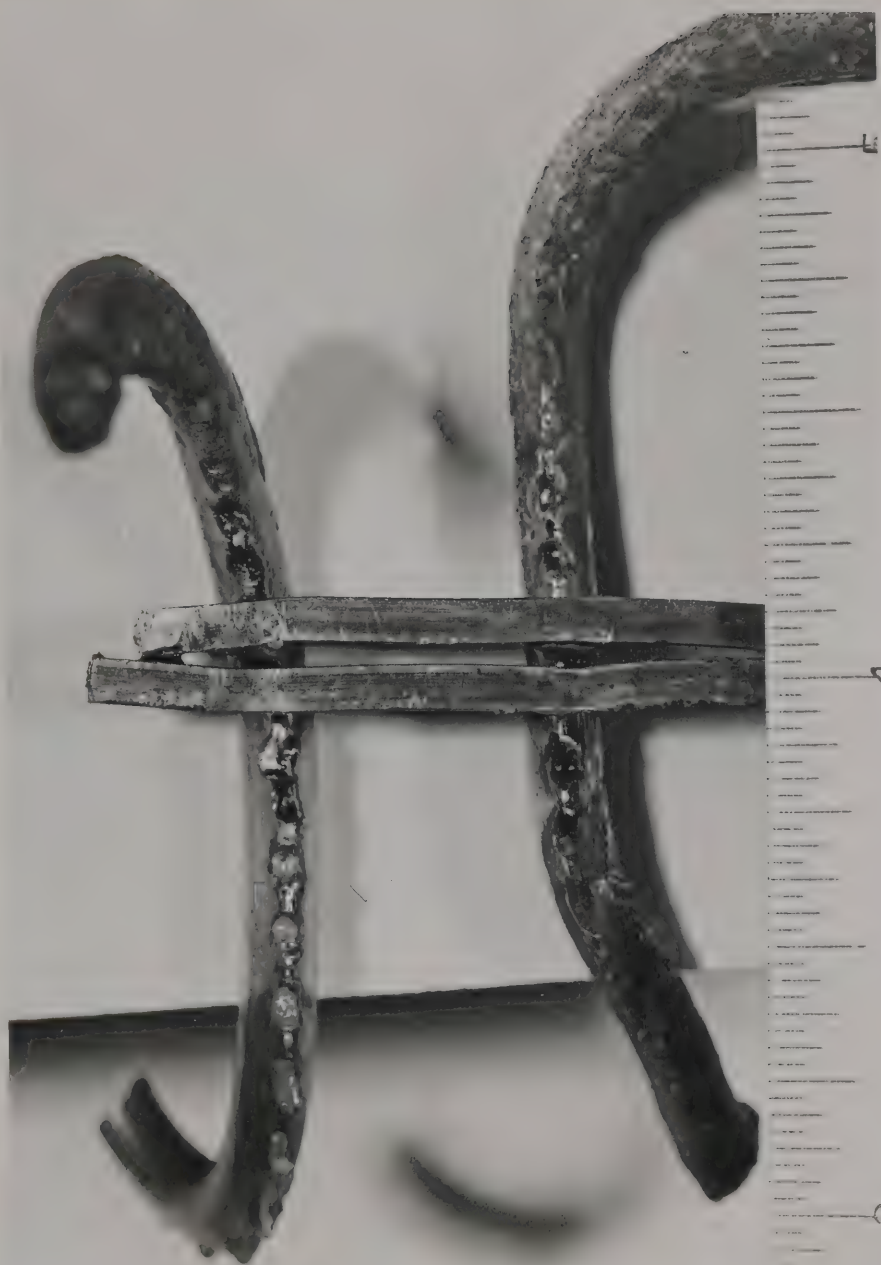
Plate I Enlargement of reconstructed segment of 40 slot Johnson well screen (exterior view).

The recovered label identified the screen as being a Johnson Everdur 40 slot screen, ten feet long and eight inch in diameter (7.5 od, 6.38 id). Plate I shows an external view of a partially restored section of screen made from pieces recovered by the bailer. The vertical pieces were almost completely covered by a coating of sand grains cemented on by iron oxide. This coating covered the weld areas as well as the ends of the vertical pieces showing that they were not broken loose by the recent bailing operations, but must have lain on the bottom of the well for some time.

These pieces were recovered by the bailer at Well No. 3 at Iroquois Service Area. The encrustations visible at the uncleaned ends of the vertical struts are sand grains cemented on by iron oxide. The fact that they coat the weld areas and ends of the vertical pieces shows that these pieces were not broken loose by the last bailing operation

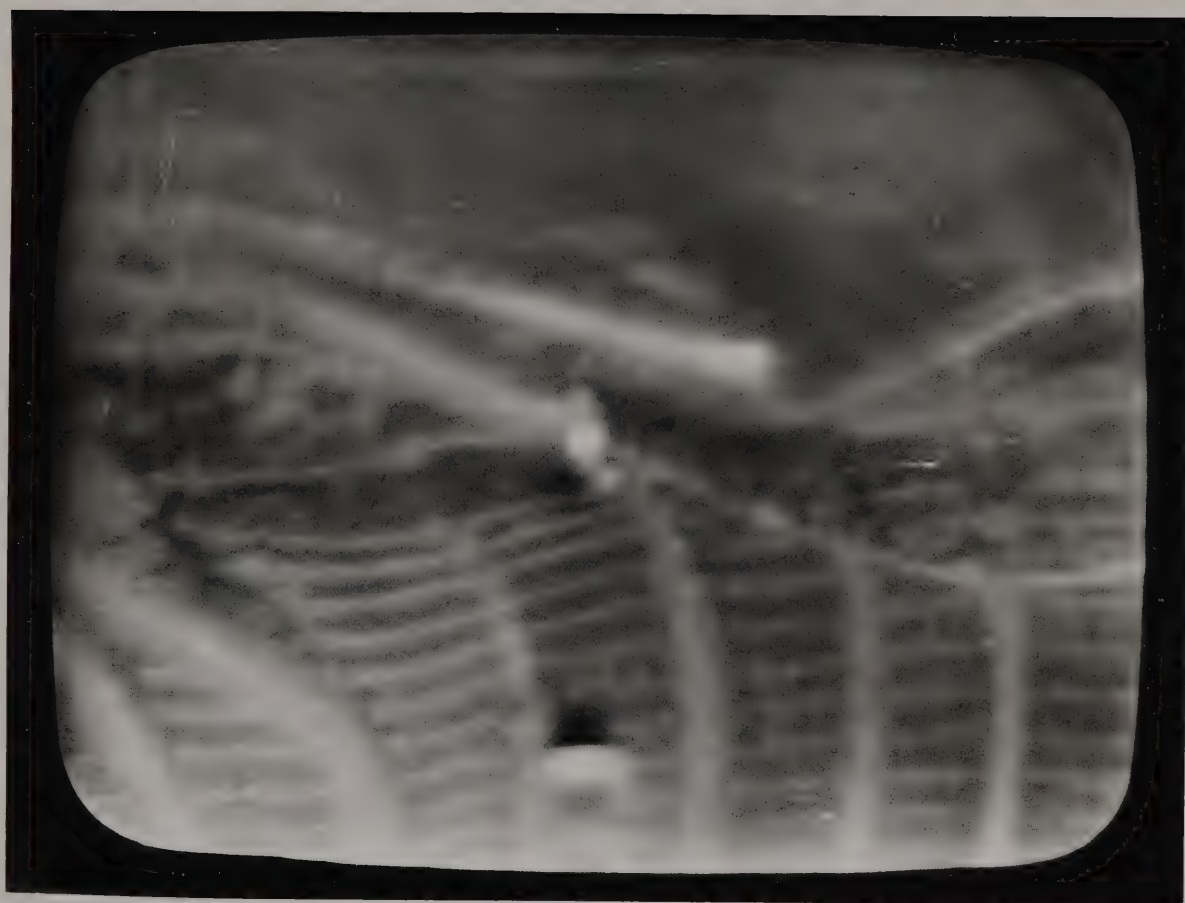
Plate II View showing damage at top of well screen.  
Continuation of Plate IV.

The damaged top of the screen is shown in Plates II & III. The brass collar and lead seal are both missing. They are probably in the bottom of the well screen, unless they were recovered in some previous bailing operation. Quite a bit of the horizontal "V" section bar was recovered by the bailer, however, there is approximately 16 feet of this "V" section bar to the inch of screen length. The T.V. inspection showed that the damaged area below the missing collar may be only four inches. There is 3.2 feet of screen at present between the damaged top as shown in Plate II and the bottom (lowest point to which the T.V. probe would penetrate). This means that there is probably 4.3±

The two pieces in the upper left are vertical members which have been bent over. The wide spots on the horizontal member that winds across the center of the picture are weld marks. The brass collar to which the vertical members were attached and the lead seal are apparently missing.

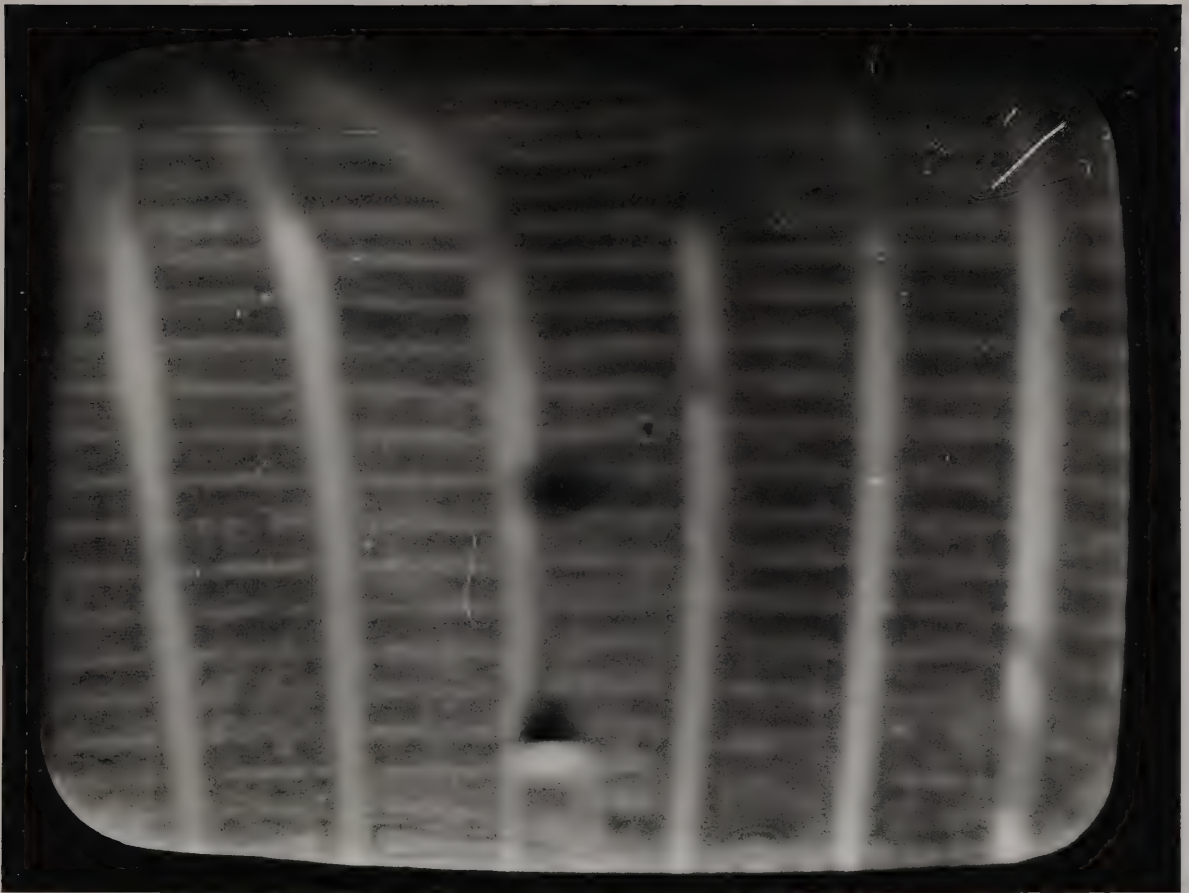
Plate III View showing well screen at base of damaged area.

The section of the screen that could be examined with the radial view T.V. probe showed no damage below this point.

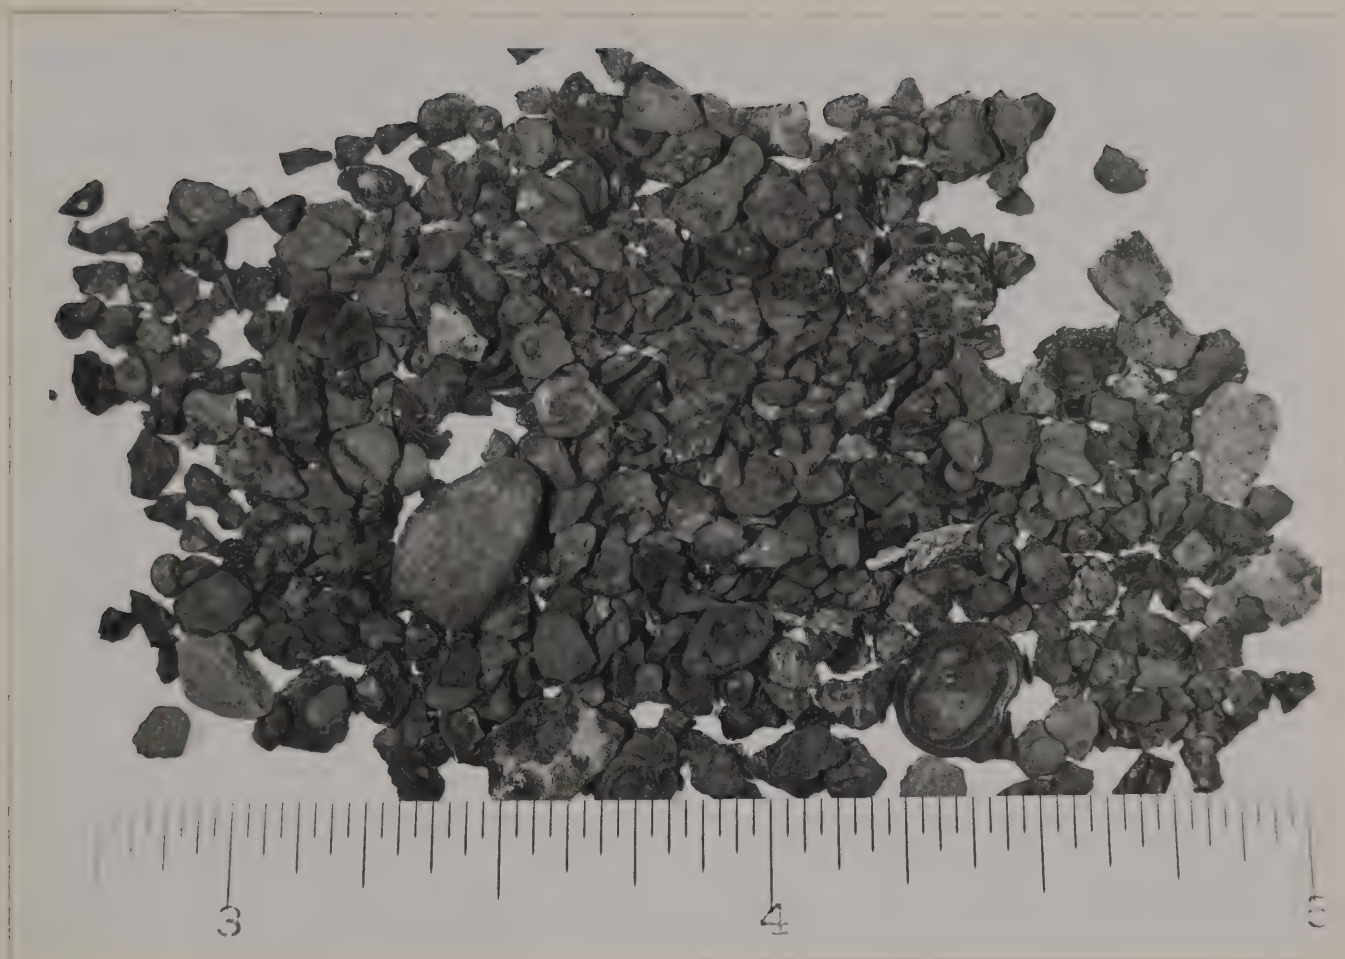
Plate IV Enlarged view of material retained by No. 14 sieve. Sample taken by bailer.

Plates IV & V show the material recovered by the bailer separated according to that passing or being retained by the No. 14 sieve. The coarser material consists mainly of rust particles from the casing. There are a few pieces of sandstone and crystalline too coarse to be passed by the well screen. They may have entered the well between the casing and the screen since the seal is no longer present. Figures 1 and 2 show the grain size analysis of the samples taken by the bailer and from the softening wier respectively. Over 90% by weight of the material in both samples could pass a No. 40 well screen. Over 90% of the remaining material is rust particles from inside the casing.

Most of the material shown is iron oxide. The 3/8 in. pebble in the lower left is sandstone.
